**EXPERIMENTAL INVESTIGATION OF THE  
INTERACTION OF MOISTURE, LOW TEMPERATURE, AND  
LOW LEVEL IMPACT ON GRAPHITE/EPOXY COMPOSITES**

PREPARED BY  
K. N. LAURAITIS  
P.E. SANDORFF

**LOCKHEED-CALIFORNIA COMPANY  
BURBANK, CALIFORNIA**

FINAL REPORT  
OCTOBER 1980

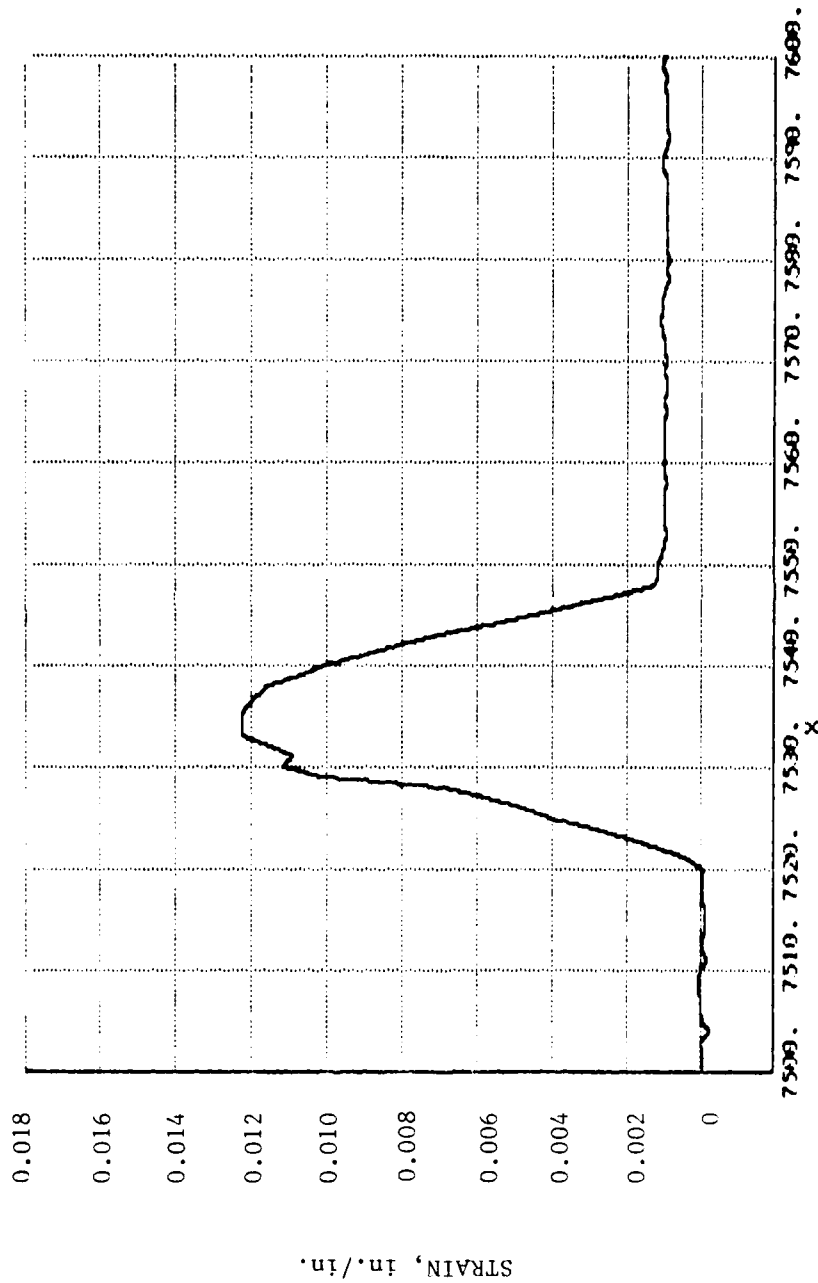
Figure 3-7: Strain Data for 6.2 ft.-lb. Impact of Specimen 1X01620B-4 (25,000 Scans/Sec.)

In tests in which strain gage data were obtained, a centralized data acquisition, recording, and processing system was used which provides a demonstrated overall accuracy of one percent through null calibration of individual sensors and digitalization of data. A typical strain record obtained in a representative impact test is presented in Figure 3-7; here the horizontal scale is proportional to time. This record is interpreted as indicating failure at a strain of .0123 in/in, which (from the static calibration) corresponds to a force of 560 lb.

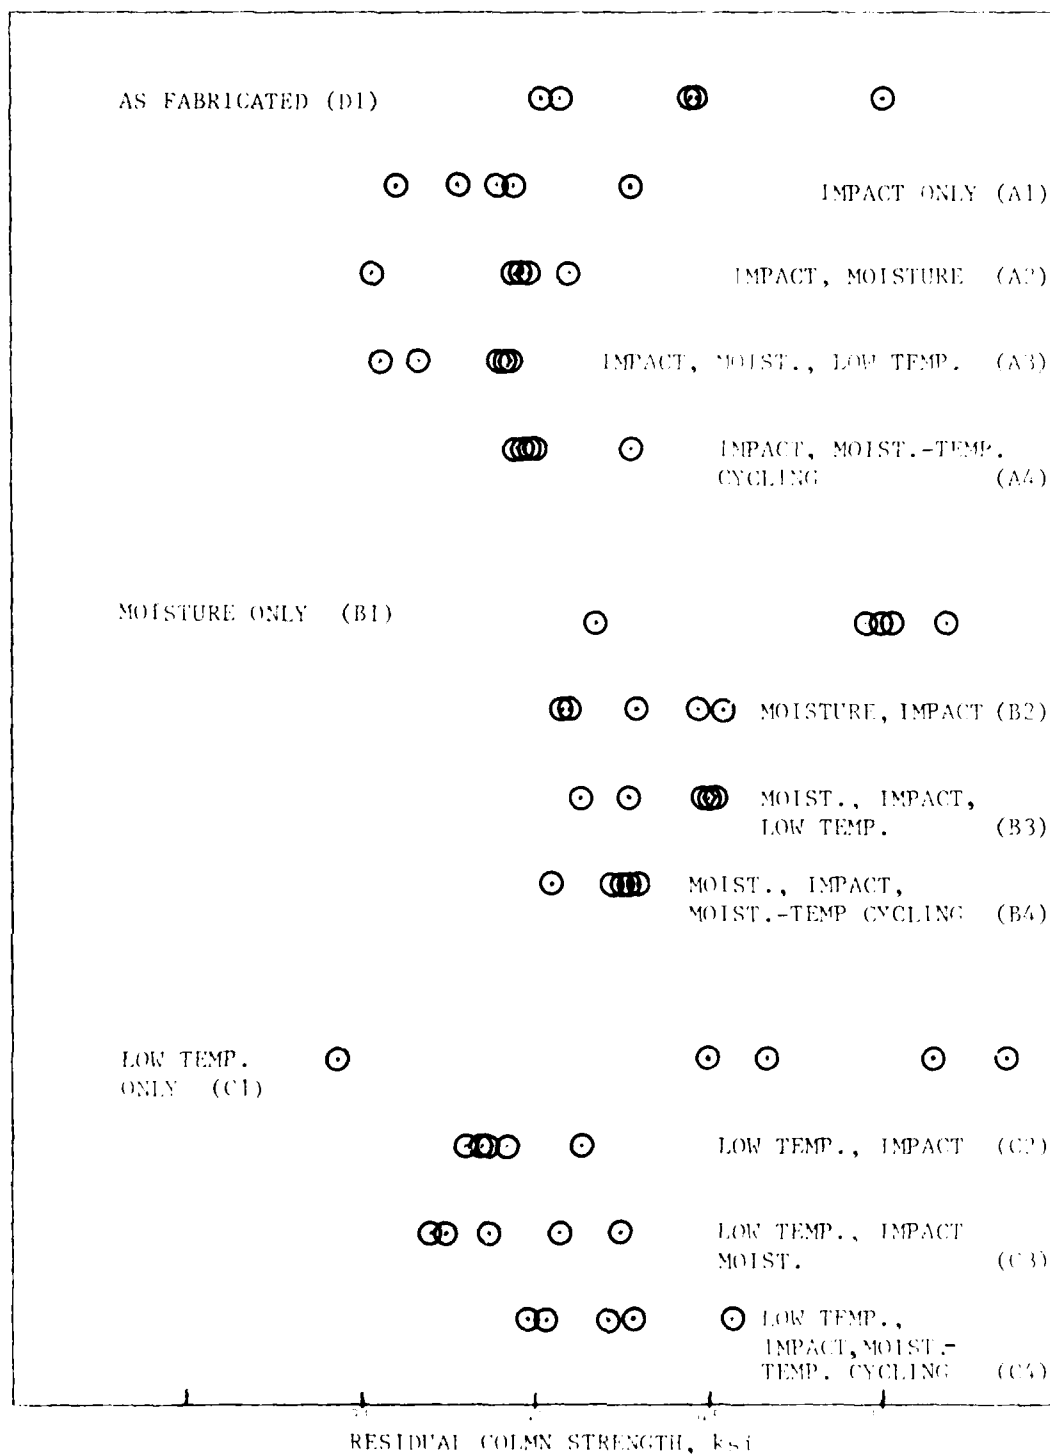
Figure 5-1: Results of Residual Column Strength Tests.

The scatter of individual test data, expressed by the coefficient of variation, is of the order of five percent. When using only five replicate specimens, differences between the mean values must be more than twice as large as the coefficient of variation to be considered significant to a 90 percent confidence level. No differences this large are found between the mean values in Table 5-2, except when comparing impact-damaged specimens with those not impacted at all. The immediate results of the test program, therefore, are that **these** specific environmental exposures and sequences of exposures have no significant effect on impact damage or on residual compressive strength after impact. This conclusion is graphically evident in Figure 5-1. Here it is seen that, for each of the three conditions of exposure prior to impact, the impact damage reduces the residual compressive strength, but environmental exposure subsequent to impact causes no further reduction.

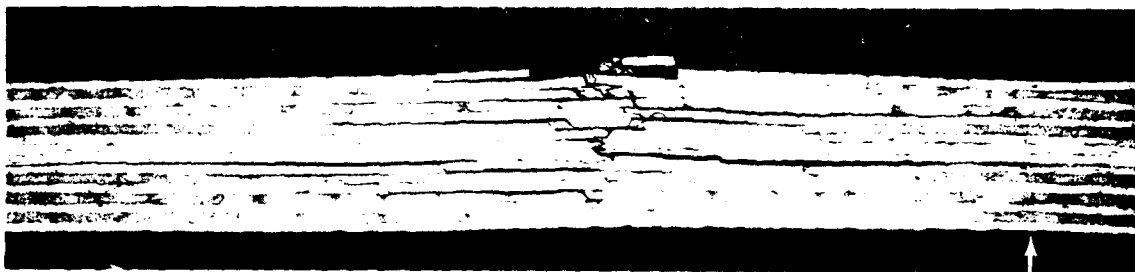
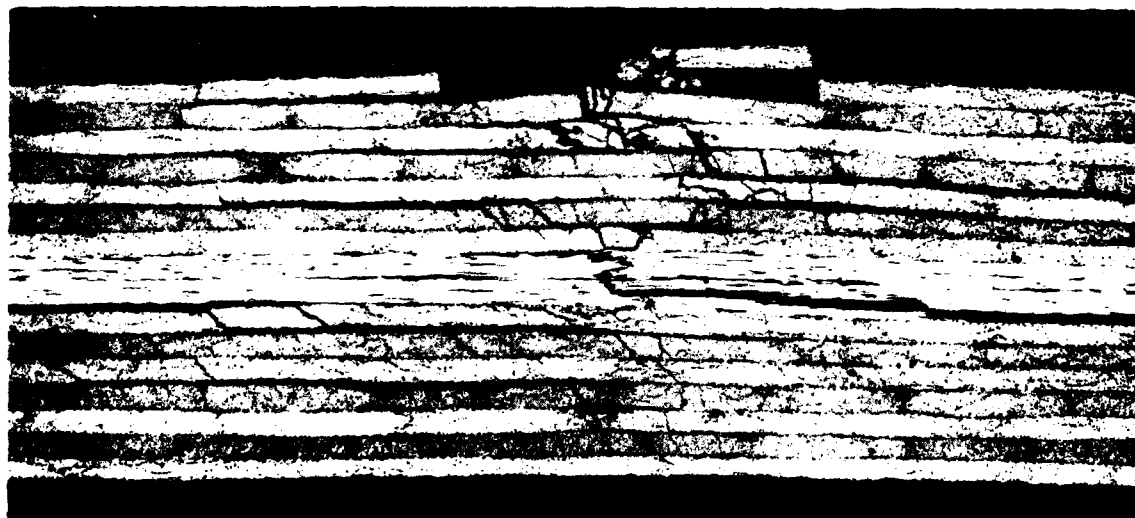
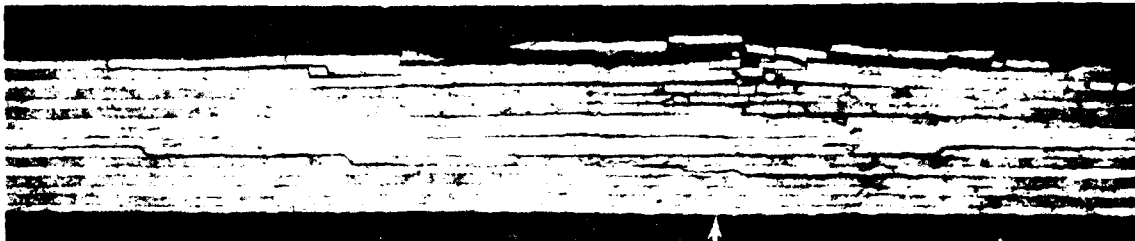
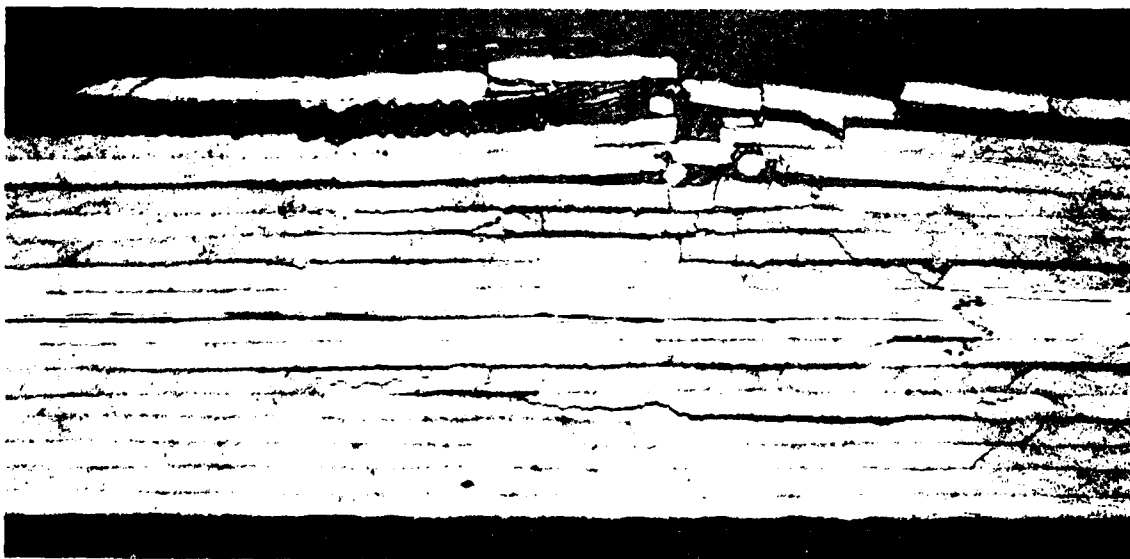
Figure 12. Micrograph of a cross-section through a layered material, showing the impact location. The impact location is marked by a small white arrow pointing upwards from the text 'Impact Location' below the image.

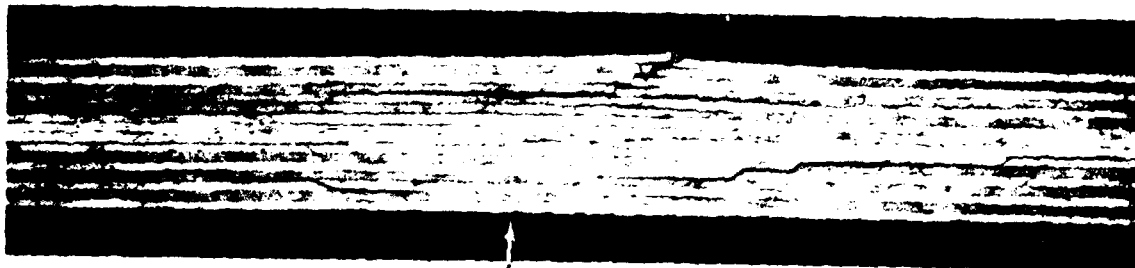
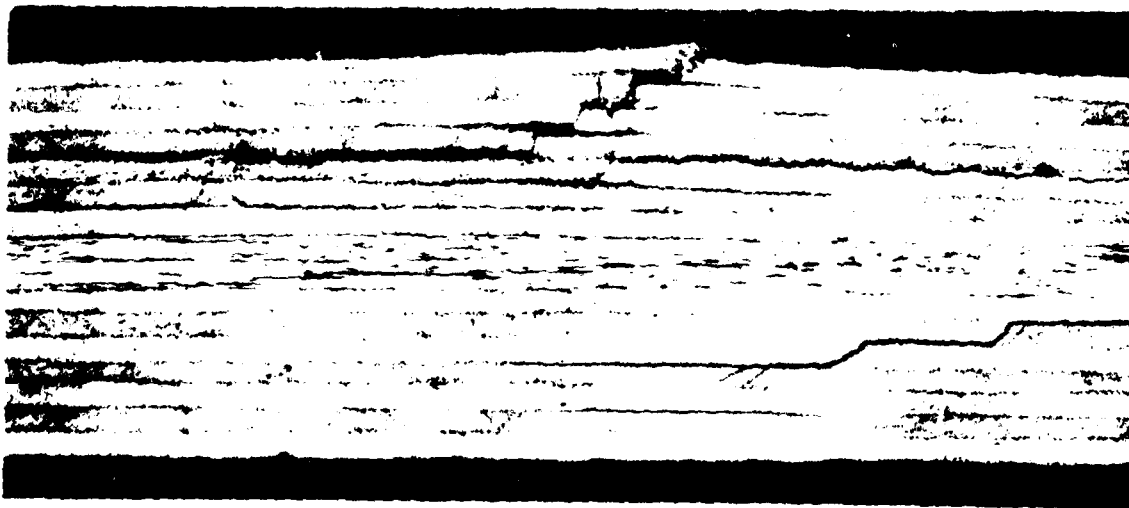
Figure 11-1. Micrographs of the impact site. The top micrograph shows the impact site on the surface of the material. The bottom micrograph shows the impact site on the cross-section of the material.

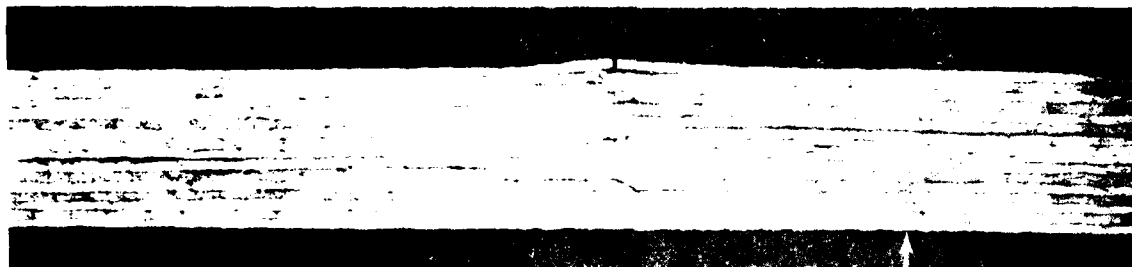
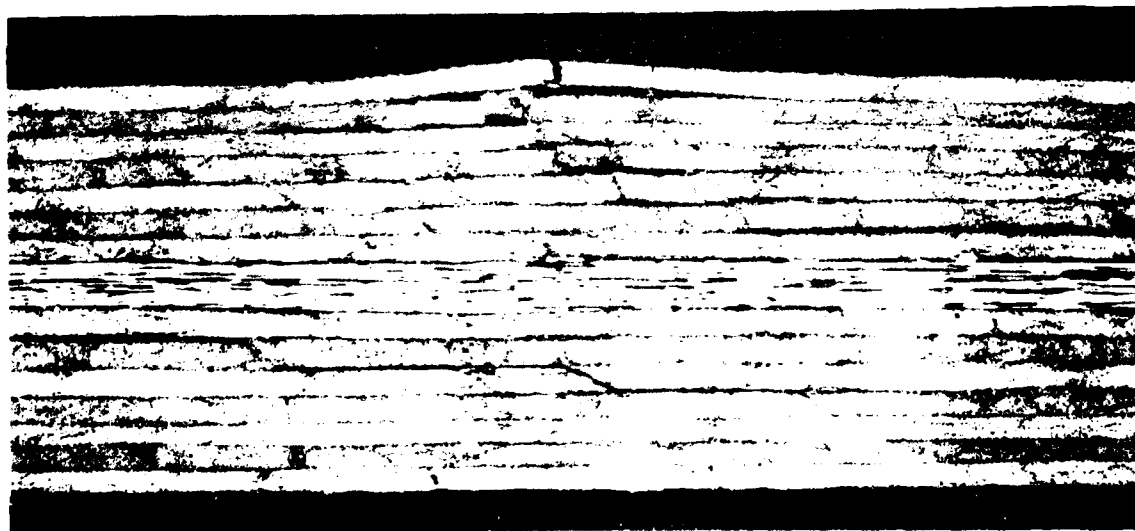
Figure 12: Micrographs of Section across Impact Station of Specimen 20A-2, Subjected to Low Temperature Exposure, Impact, Vibration, Conditioning, Delamination Extends 0.873-inch from Station.
